Site survey report

Name: Eurofyre Limited
Address: Knowle Village Business Park
Building: Unit C1
Floor:
Description: Xenos survey report for demonstration purposes.
Surveys: Xenos Wireless Fire Alarm

Summary report on survey: Xenos Wireless Fire Alarm

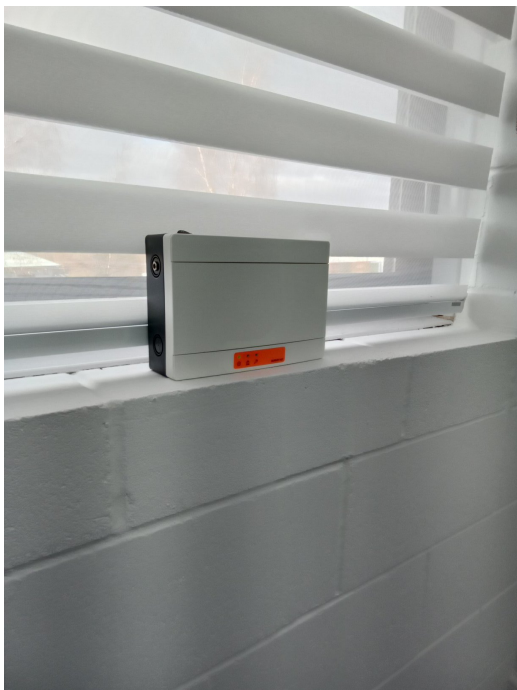
INTELLIGENT TRANSLATOR MODULE

Survey: Xenos Wireless Fire Alarm
Description: X1
Location: Reception
Connected devices: 11

Infrastructure		Device	
Channels	9	45	55	25
Background noise average:	-119 dBm	-120 dBm	-120 dBm	-120 dBm
Background noise variability:	5.377 dBm	2.702 dBm	0.755 dBm	0.879 dBm
Status:	GOOD	GOOD	GOOD	GOOD

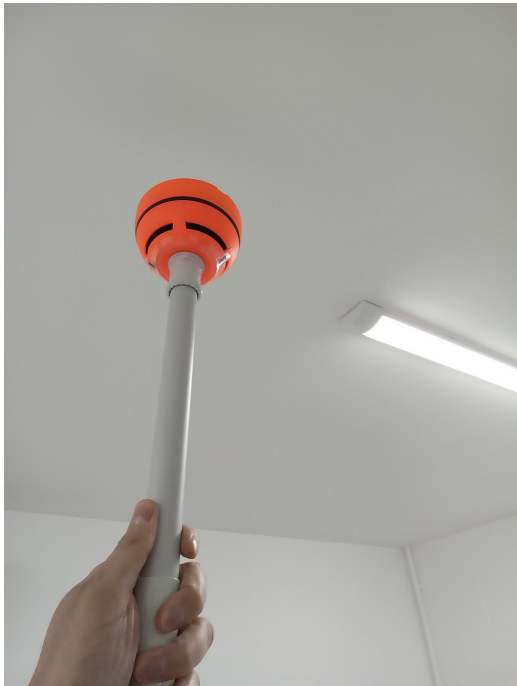
OPTICAL DETECTOR

Survey: Xenos Wireless Fire Alarm
Description: X2
Location: Reception
Connected to: INTELLIGENT TRANSLATOR MODULE - Reception

RSSI Avg:	-33 dBm	RSSI Var:	0.000 dBm
Background Avg:	-115 dBm	Background Var:	1.252 dBm
Packet loss:	0%	Scan performed on channel:	Default
Status:	GOOD

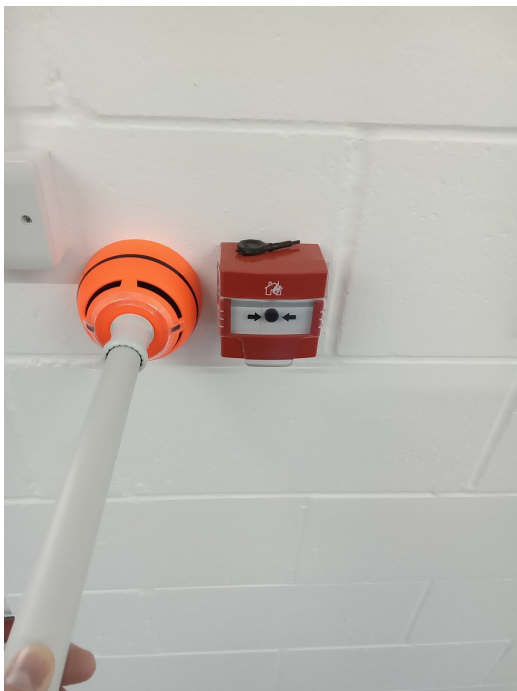
CALL POINT (RED)

Survey: Xenos Wireless Fire Alarm
Description: X3
Location: Reception
Connected to: INTELLIGENT TRANSLATOR MODULE - Reception

RSSI Avg:	-52 dBm	RSSI Var:	2.522 dBm
Background Avg:	-117 dBm	Background Var:	1.729 dBm
Packet loss:	0%	Scan performed on channel:	Default
Status:	GOOD

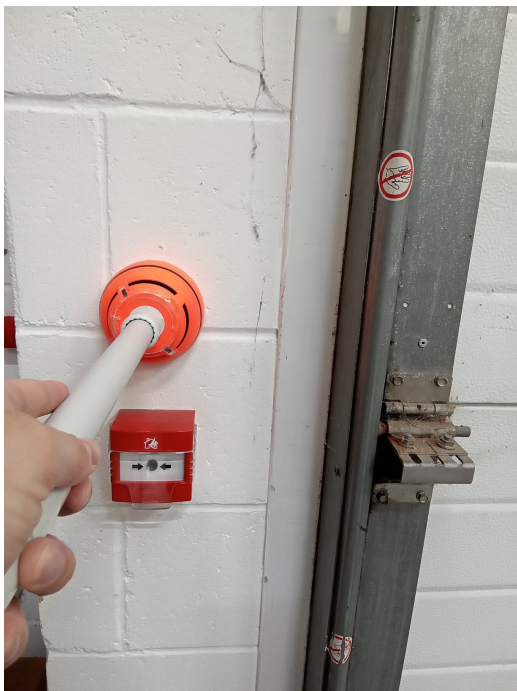
CALL POINT (RED)

Survey: Xenos Wireless Fire Alarm
Description: X4
Location: Warehouse
Connected to: INTELLIGENT TRANSLATOR MODULE - Reception

RSSI Avg:	-55 dBm	RSSI Var:	1.285 dBm
Background Avg:	-116 dBm	Background Var:	1.182 dBm
Packet loss:	0%	Scan performed on channel:	Default
Status:	GOOD

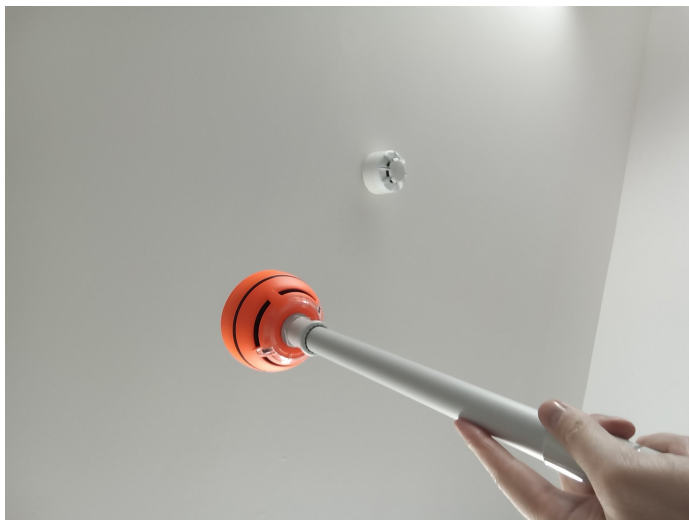
OPT OPTICAL DETECTOR

Survey: Xenos Wireless Fire Alarm
Description: X6
Location: Packing Area
Connected to: INTELLIGENT TRANSLATOR MODULE - Reception

RSSI Avg:	-49 dBm	RSSI Var:	2.612 dBm
Background Avg:	-115 dBm	Background Var:	3.143 dBm
Packet loss:	0%	Scan performed on channel:	Default
Status:	GOOD

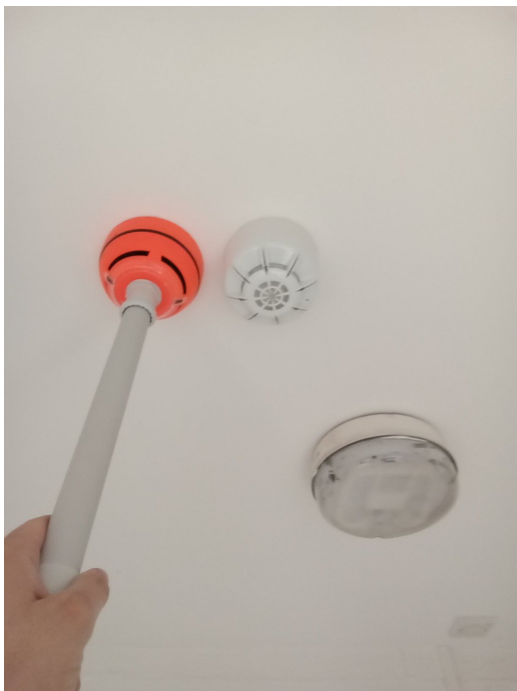
THERMAL DETECTOR

Survey: Xenos Wireless Fire Alarm
Description: X7
Location: Kitchen
Connected to: INTELLIGENT TRANSLATOR MODULE - Reception

RSSI Avg:	-51 dBm	RSSI Var:	0.000 dBm
Background Avg:	-115 dBm	Background Var:	1.112 dBm
Packet loss:	0%	Scan performed on channel:	Default
Status:	GOOD

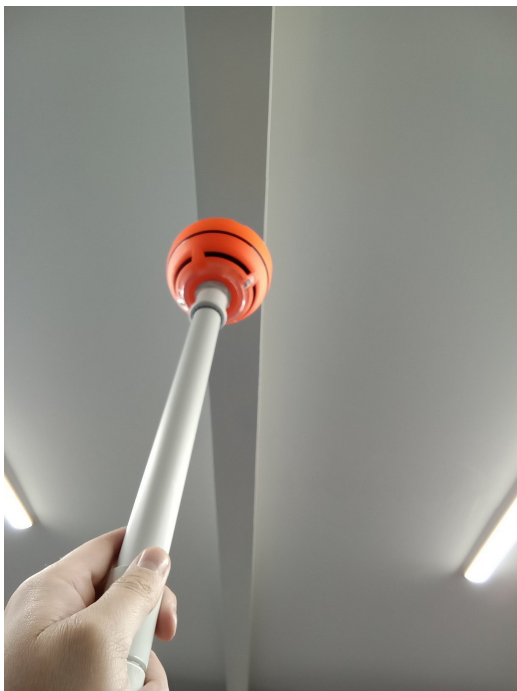
OPT OPTICAL DETECTOR

Survey: Xenos Wireless Fire Alarm
Description: X8
Location: Workshop
Connected to: INTELLIGENT TRANSLATOR MODULE - Reception

RSSI Avg:	-47 dBm	RSSI Var:	1.069 dBm
Background Avg:	-116 dBm	Background Var:	1.775 dBm
Packet loss:	0%	Scan performed on channel:	Default
Status:	GOOD

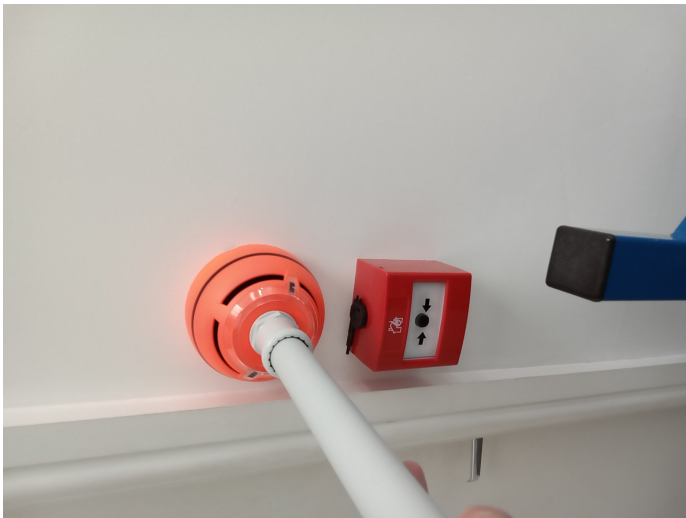
CALL POINT (RED)

Survey: Xenos Wireless Fire Alarm
Description: X9
Location: Stairs
Connected to: INTELLIGENT TRANSLATOR MODULE - Reception

RSSI Avg:	-50 dBm	RSSI Var:	1.484 dBm
Background Avg:	-115 dBm	Background Var:	1.181 dBm
Packet loss:	0%	Scan performed on channel:	Default
Status:	GOOD

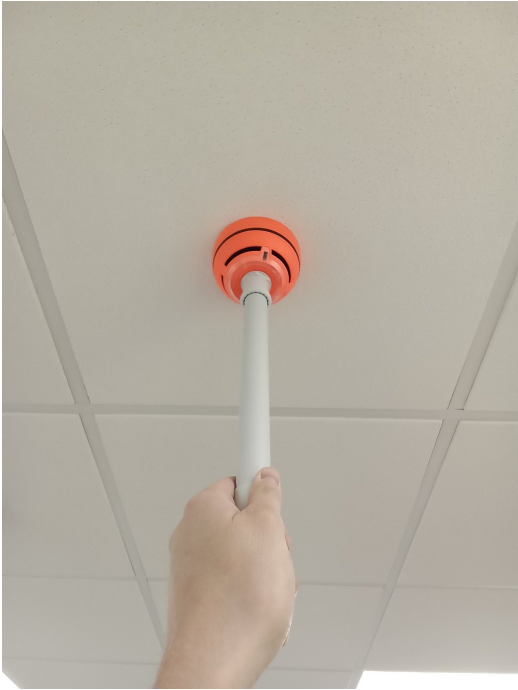
OPT OPTICAL DETECTOR

Survey: Xenos Wireless Fire Alarm
Description: X10
Location: Office 1
Connected to: INTELLIGENT TRANSLATOR MODULE - Reception

RSSI Avg:	-46 dBm	RSSI Var:	0.598 dBm
Background Avg:	-116 dBm	Background Var:	3.600 dBm
Packet loss:	0%	Scan performed on channel:	Default
Status:	GOOD

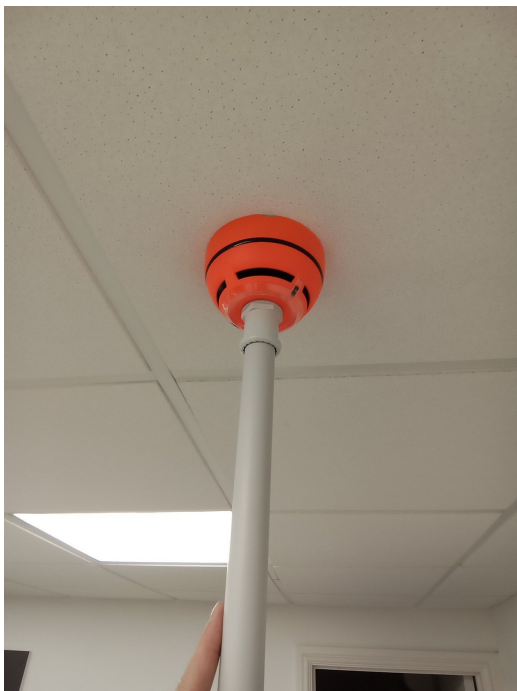
OPT OPTICAL DETECTOR

Survey: Xenos Wireless Fire Alarm
Description: X11
Location: Office 11
Connected to: INTELLIGENT TRANSLATOR MODULE - Reception

RSSI Avg:	-51 dBm	RSSI Var:	0.656 dBm
Background Avg:	-113 dBm	Background Var:	3.036 dBm
Packet loss:	0%	Scan performed on channel:	Default
Status:	GOOD

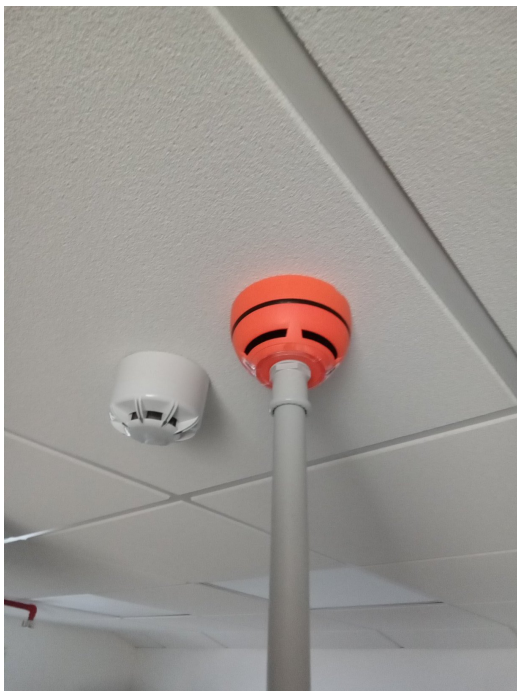
OPT OPTICAL DETECTOR

Survey: Xenos Wireless Fire Alarm
Description: X12
Location: Meeting Room
Connected to: INTELLIGENT TRANSLATOR MODULE - Reception

RSSI Avg:	-51 dBm	RSSI Var:	0.485 dBm
Background Avg:	-116 dBm	Background Var:	1.483 dBm
Packet loss:	0%	Scan performed on channel:	Default
Status:	GOOD
